FLOOD PLAIN MANAGEMENT STUDY

FRYE CREEK - SPRING CANYON TOWN OF THATCHER

Graham County, Arizona

JUNE 1986

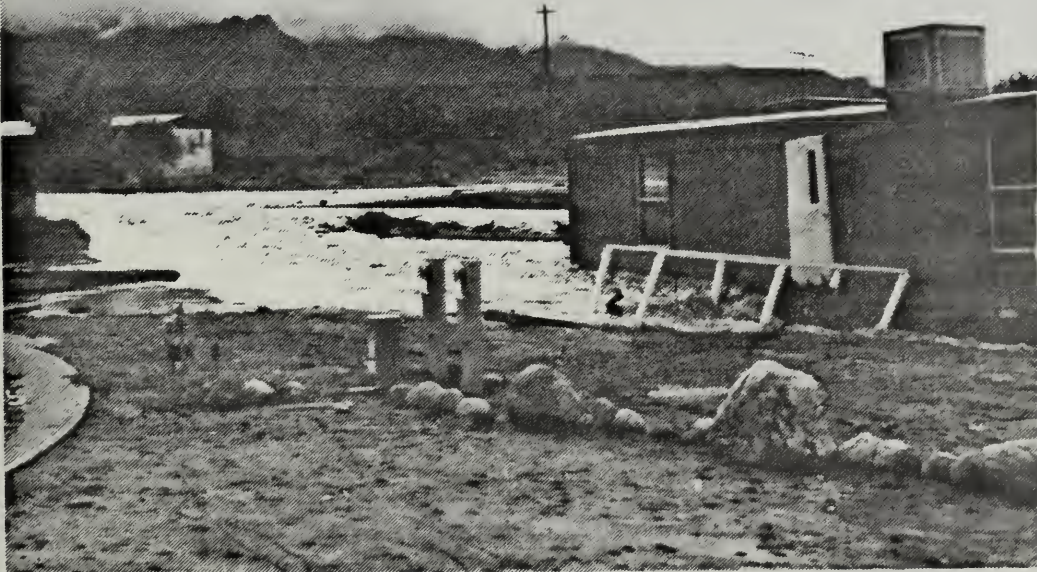
FIGURE 3: FRYE CREEK, OCTOBER 1983 FLOOD

Looking southwest from a point near the north end
of Sage Trail Street.

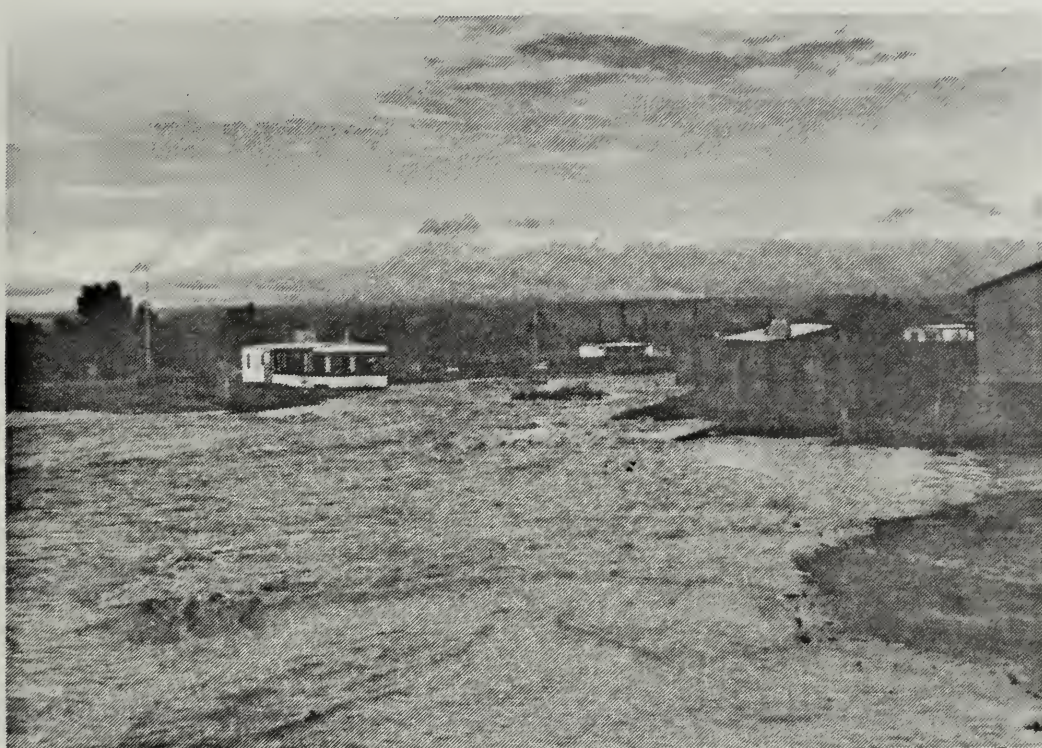
FIGURE 4: FRY CREEK, OCTOBER 1983 FLOOD
Looking north-northeast from a point on Frye
Creek Road.

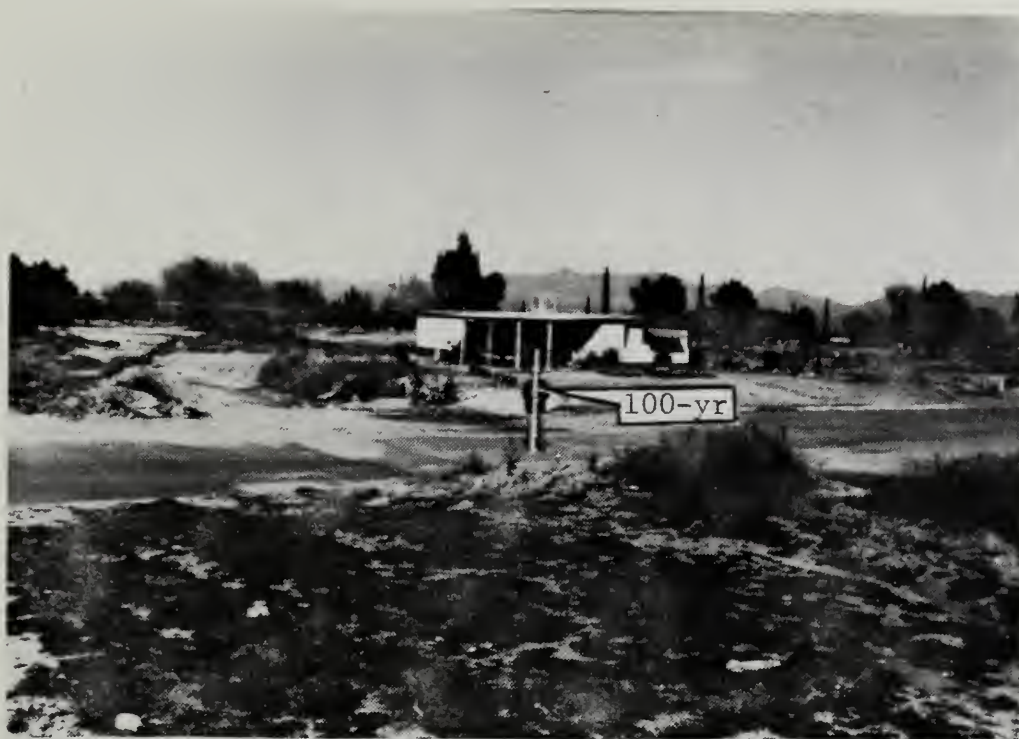
FRYE CREEK at Frye Creek Road; looking north, with Safford Municipal Golf Course in background. Depth, 5 ft.

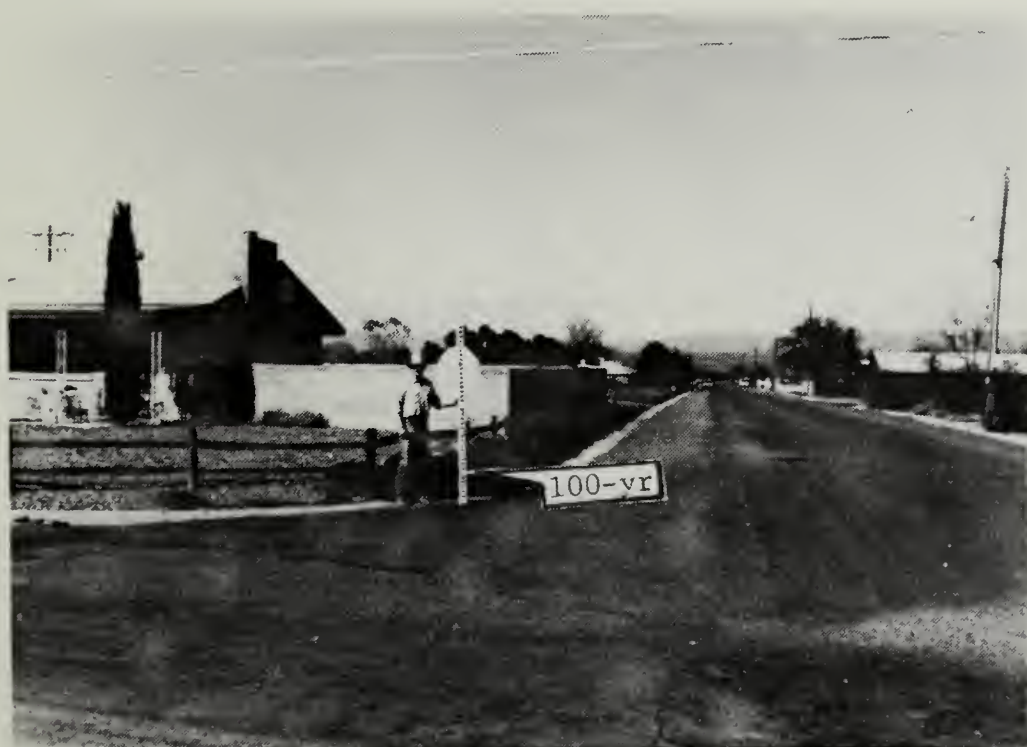
Looking north at Fairway Avenue at intersection of Brinkerhoff Street and Fairway Avenue. Depth, 1.3. ft.

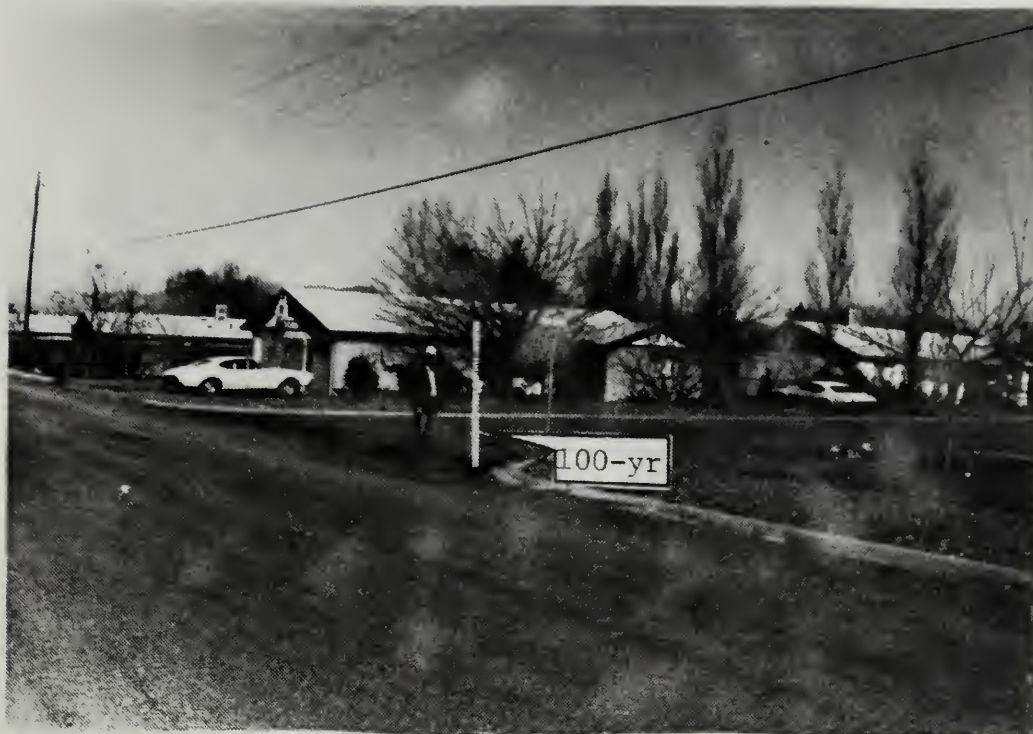
Intersection of Pace Street and Fairway Avenue;
Fairway Avenue in left foreground. Depth, 1.9 ft.

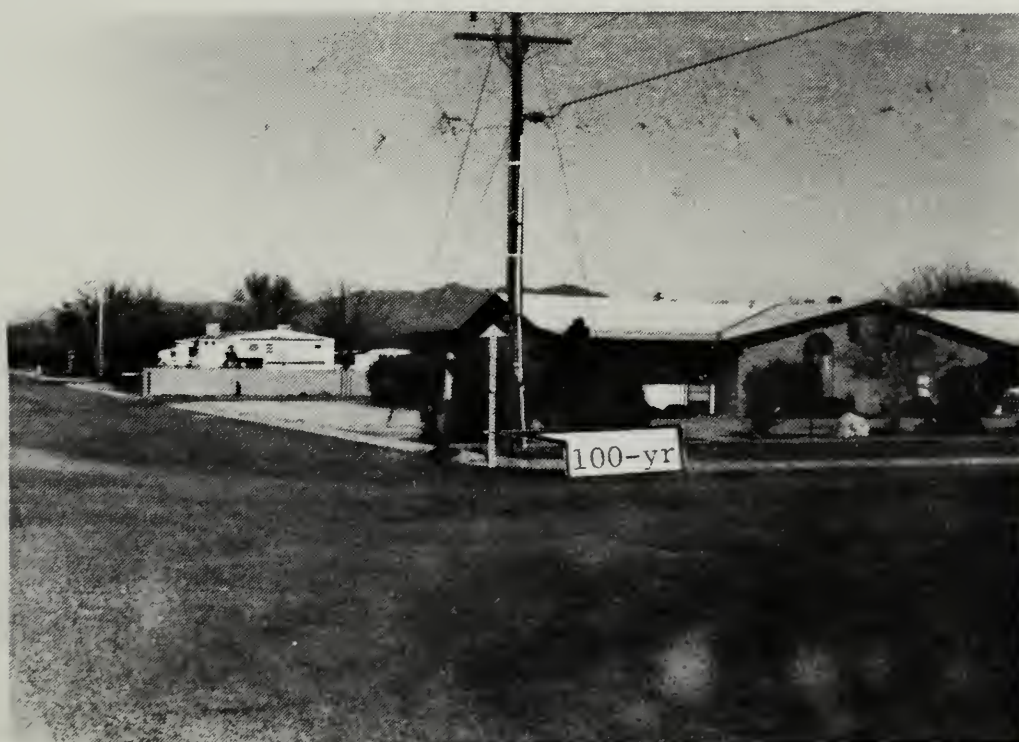
Intersection of Golf Course Street and Fairway
Avenue; Fairway Avenue on left of photo. Depth, 2.0 ft.

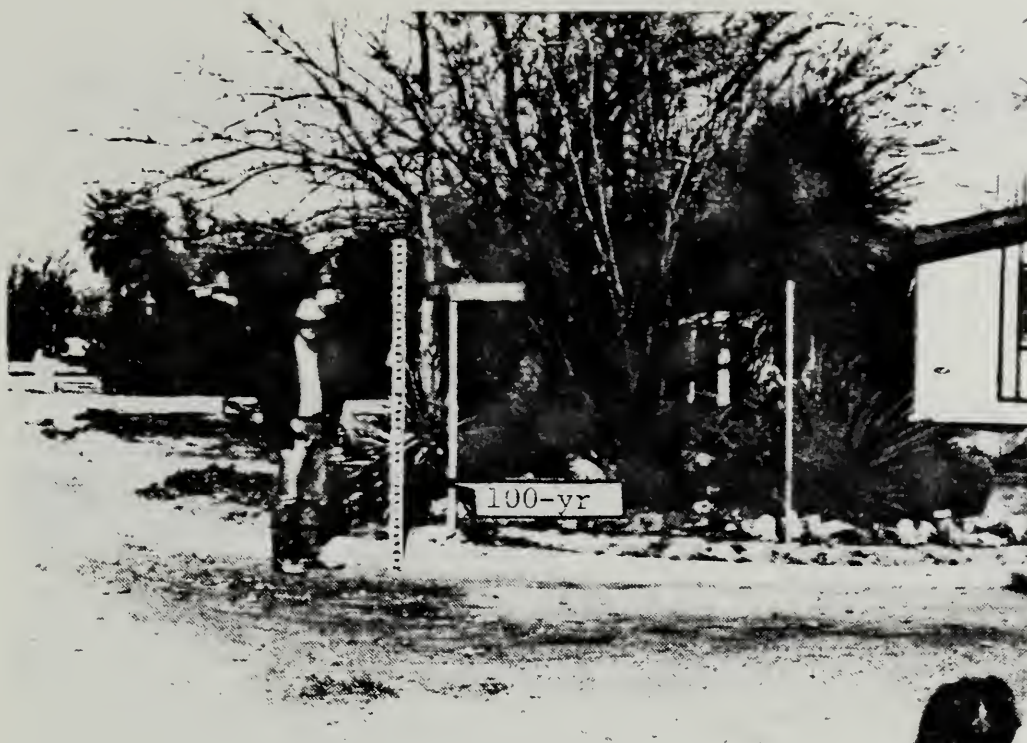
Intersection of Bingham Street and
Fairway Avenue. Depth, 2.2 ft.

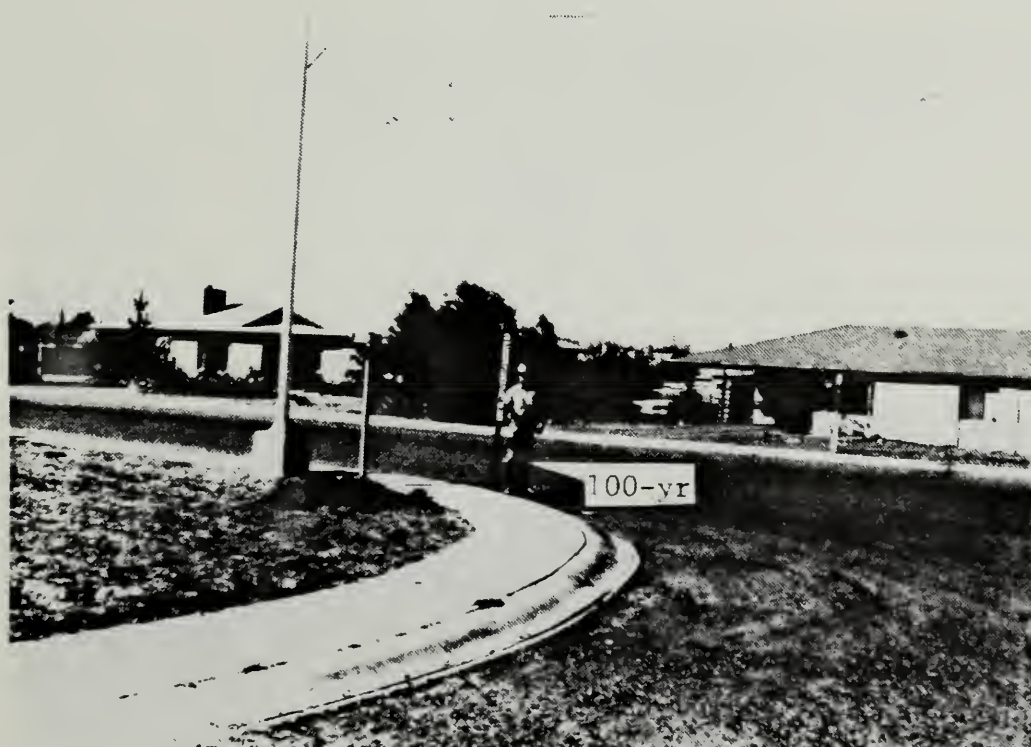
Intersection of Kimball Street and Robinson Avenue.
Depth, 1.5 ft.

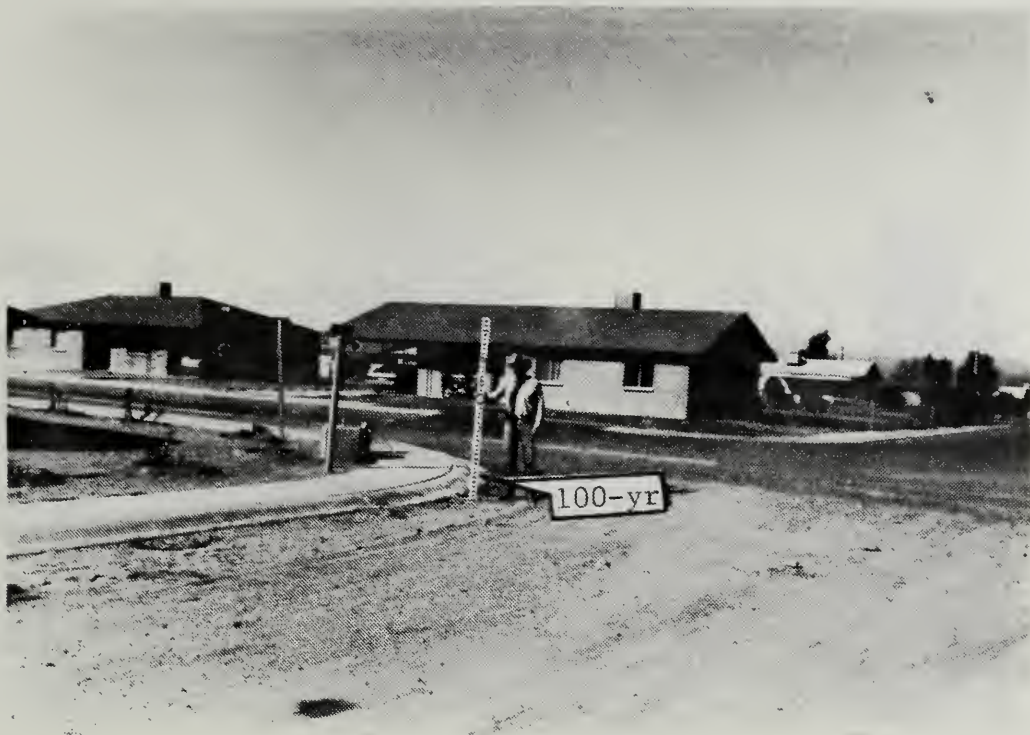
Intersection of Fuller Street and Hoopes Avenue,
Hoopes Avenue on right of photo. Depth, 1.0 ft.

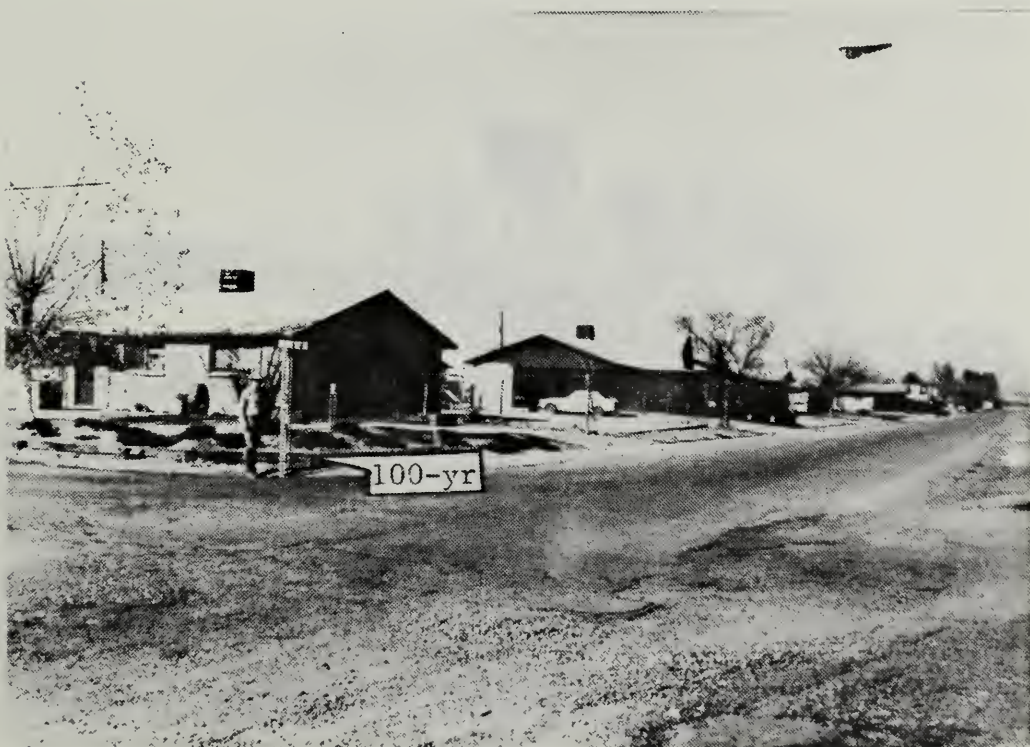
Intersection of Brinkerhoff Street and
Hoopes Avenue; looking north-northwest
with Hoopes Avenue on right. Depth, 1.5 ft.

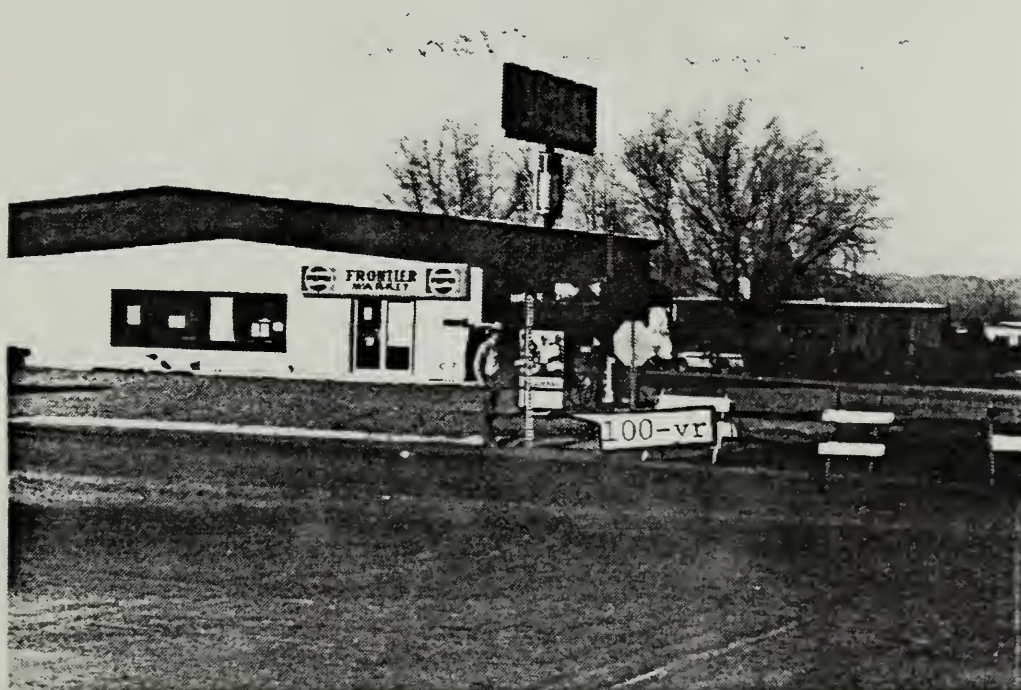
Intersection of Golf Course Street and Hoopes Avenue. Looking north-northwest. Depth, 1.8 ft.

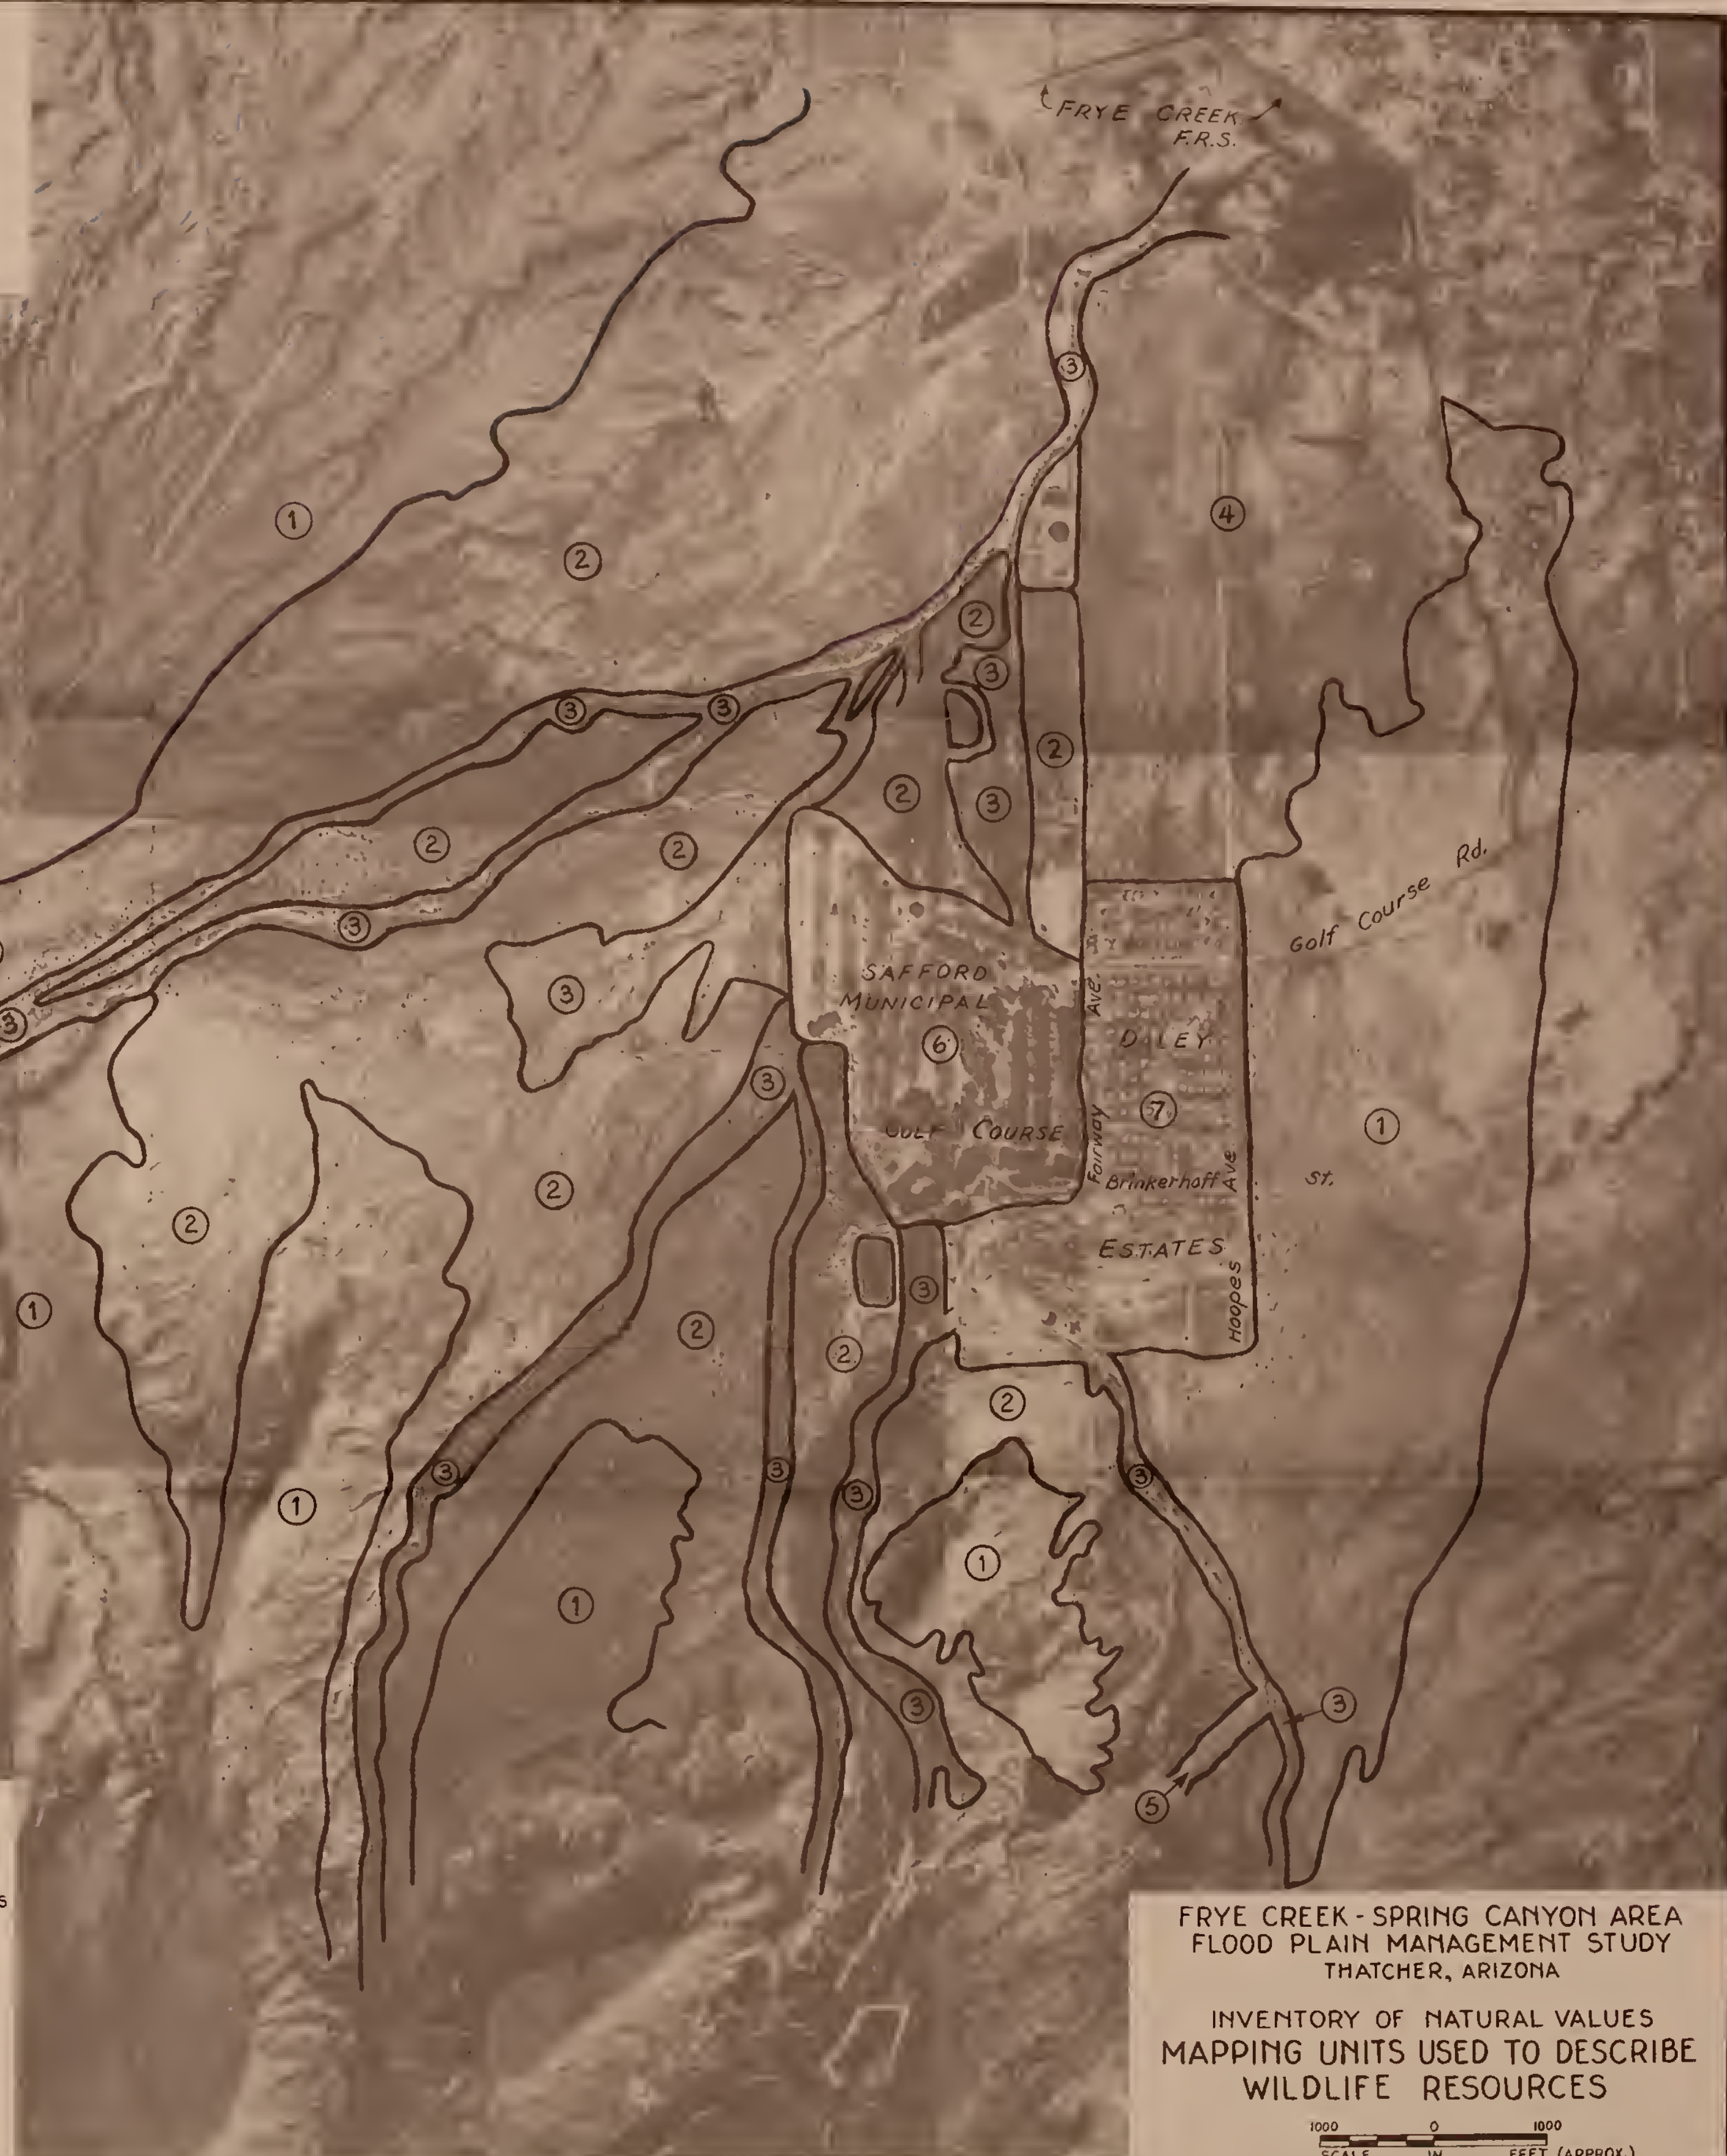
FRYE CREEK - SPRING CANYON AREA
FLOOD PLAIN MANAGEMENT STUDY
THATCHER, ARIZONA
FLOOD HAZARD MAP
100 YEAR FLOOD

A Flood Hazard Map may be found in the packet at the back of this report. The map, on a photo base, shows the 100-year flood area, the location of many of the cross sections used, the elevations of the 100-year flood at ten foot intervals and the area of shallow flooding where the average depth is one foot or less. The areas of shallow flooding include Frye Creek through the golf course and all of the Daley Estate subdivision units.
